Highly Accelerated Stress Screening of the Atlas Liquid Argon Calorimeter Front End Boards

K. Benslama, G. Brooijmans, C.-Y. Chi, D. Dannheim, I. Katsanos, J. Parsons, S. Simion
Nevis Labs, Columbia University

March 11, 2004

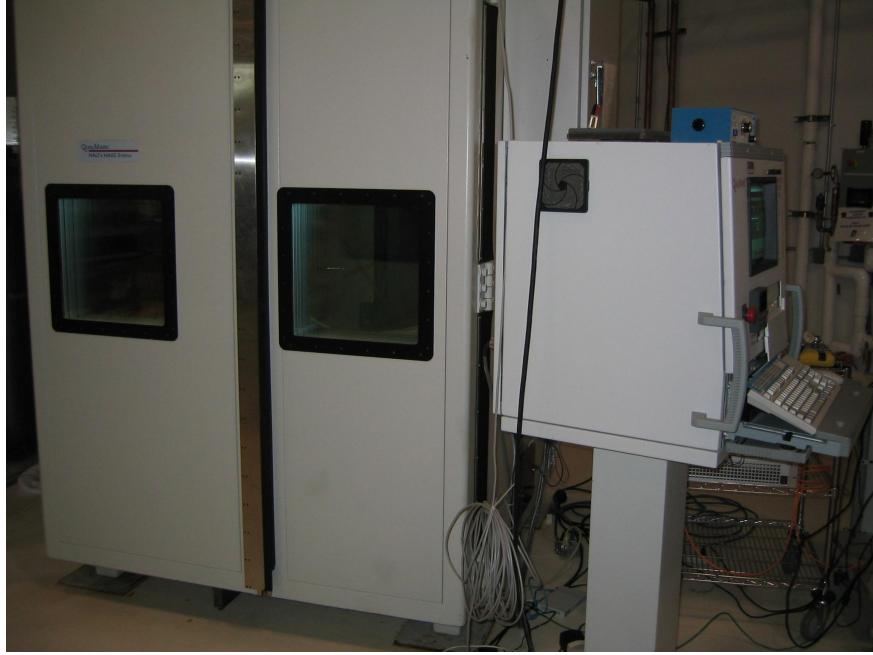
Figure 1: The Hass test chamber.

The HASS chamber is a large, insulated volume with a platform equipped with pneumatic hammers to induce vibrations (typically between 10 and 5000 Hz, and from 1 to 60 g). High-power heating elements and liquid nitrogen are used in combination with significant airflow to provide rapid temperature change in the chamber. The chamber used for the initial tests is a Qualmark HALT+HASS System OVS4 (figure 1), located at Algen Design Services [3] in New Jersey. A similar, if not the same chamber will be used during the production run.

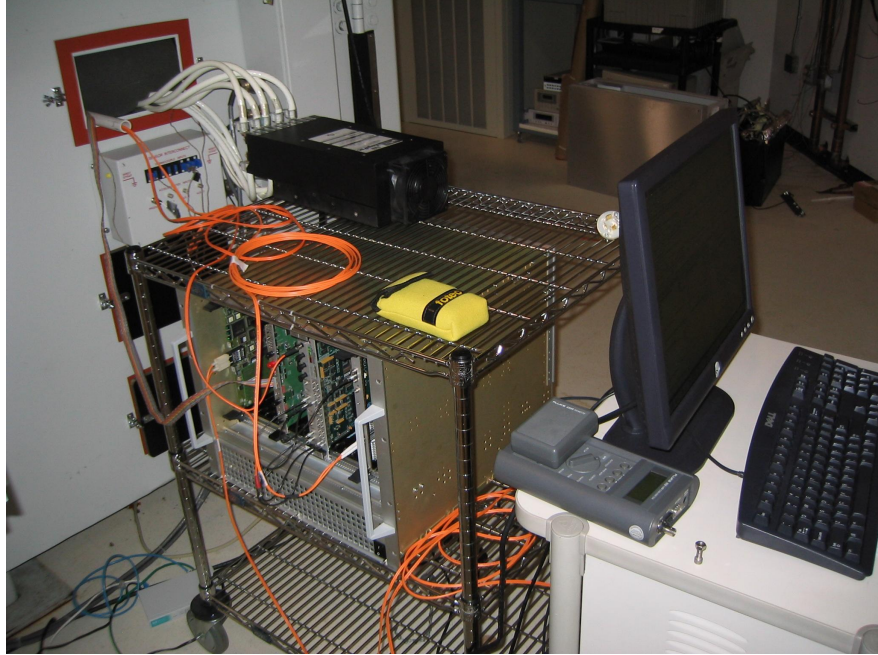
Figure 3: The power supply, 6U VME crate and PC used in the HASS test setup.

The test setup itself consists of 1 front end crate located in the HASS chamber, and a PC and VME crate next to the chamber used for controls and readout. Since the front end boards do not have cooling plates at this stage (the preamps are not mounted yet), the backplane of the front end crate has been removed to allow sufficient airflow to cool the boards. The front end boards to be tested, as well as a custom clock fanout board are inserted in every second slot in the crate, leaving the other slots open, again to allow ample airflow for cooling. The power, optical and spax cables are routed through a window in the side of the HASS chamber to a power supply and a 6U VME crate, as can be seen in figure 3. The crate contains a spacmaster,
